DOCUMENT NO. C8041-PR-024

INVESTIGATION OF INERTIA-WELDING PROCESS FOR APPLYING GILDING
METAL ROTATING BANDS TO PROJECTILE, 155-MM, M483A1

JULY 1978

FINAL TECHNICAL REPORT FOR PERIOD 29 MARCH 1976 - 31 MARCH 1978
CONTRACT DAAA25-76-C-0345

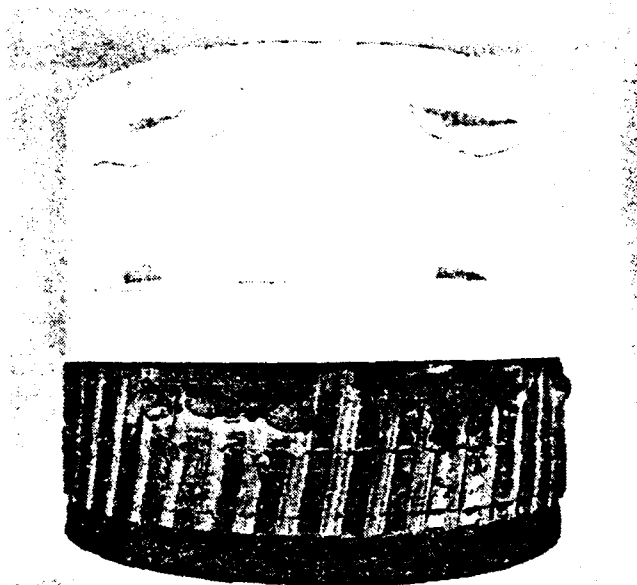
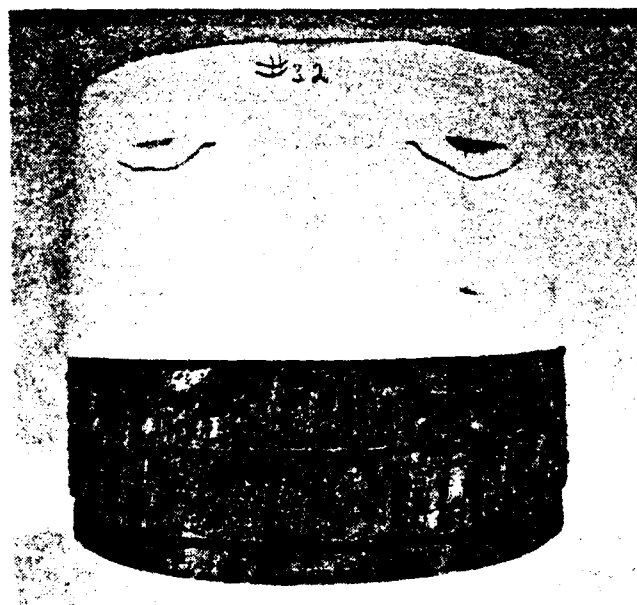
PHOTOGRAPH NO. 10800

RECOVERED M483A1 BANDS SHOWING RELATION OF SEPARATION TO ULTRASONIC SCAN
INDICATION OF A NON-BONDED CONDITION.

5.1.3 Eighteen (18) rounds were recovered which were fired at Charge, Propelling, M203 (Zone 8). Six of these rounds survived without damage or loss of band material. The remaining 12 sustained varying degrees of separation at the leading and trailing edges. Unfortunately, it has proven very difficult to equate the band loss with ultrasonic scans because in the process of transferring the round numbers during the machining operations the angular reference mark apparently was not retained, causing us to be uncertain of our witness mark location. We were able to approximate the damage areas to ultrasonic scans on some rounds, typified by Rounds 14 and 32, shown in Photograph No. 10800 on the following page. We also can see that band shear started in areas of disbond and carried through into bonded areas as shown by Photograph No. 10801 on Page 56. Note that gilding metal still adheres to the band seat next to an area of disbond. There were a number of sheared areas on other projectiles which exhibited the same characteristic.

5.1.4 After full examination of all returned hardware, we believe that band failure occurred in-bore, and that failure started in areas of disbond. A reappraisal of Zone 8 firing data substantiates this conclusion. Note in the data sheet on following page that the undamaged bands produced more consistent chamber pressures, range, and muzzle velocities. All of the "shorts" indicated by the range column occurred with rounds having damaged bands. It is our opinion that the short range rounds resulted from extra aerodynamic drag induced by partially adhered pieces of band material. On the encouraging side, chamber pressures and muzzle velocities were remarkably consistent. No bands sheared away completely, thus maintaining obturation all the way in-bore. None of the bands showed indications of in-bore projectile balloting, generally indicated by multiple rifling impressions in the band. Since these projectiles do not represent current capability with final inertia welding process, Company personnel were not overly disturbed that damage was sustained. We had an indication at this stage of the program that little, if any, disbond should be allowed on production projectiles. The complete Yuma data package for this test group is included in Pages 59 through 64.

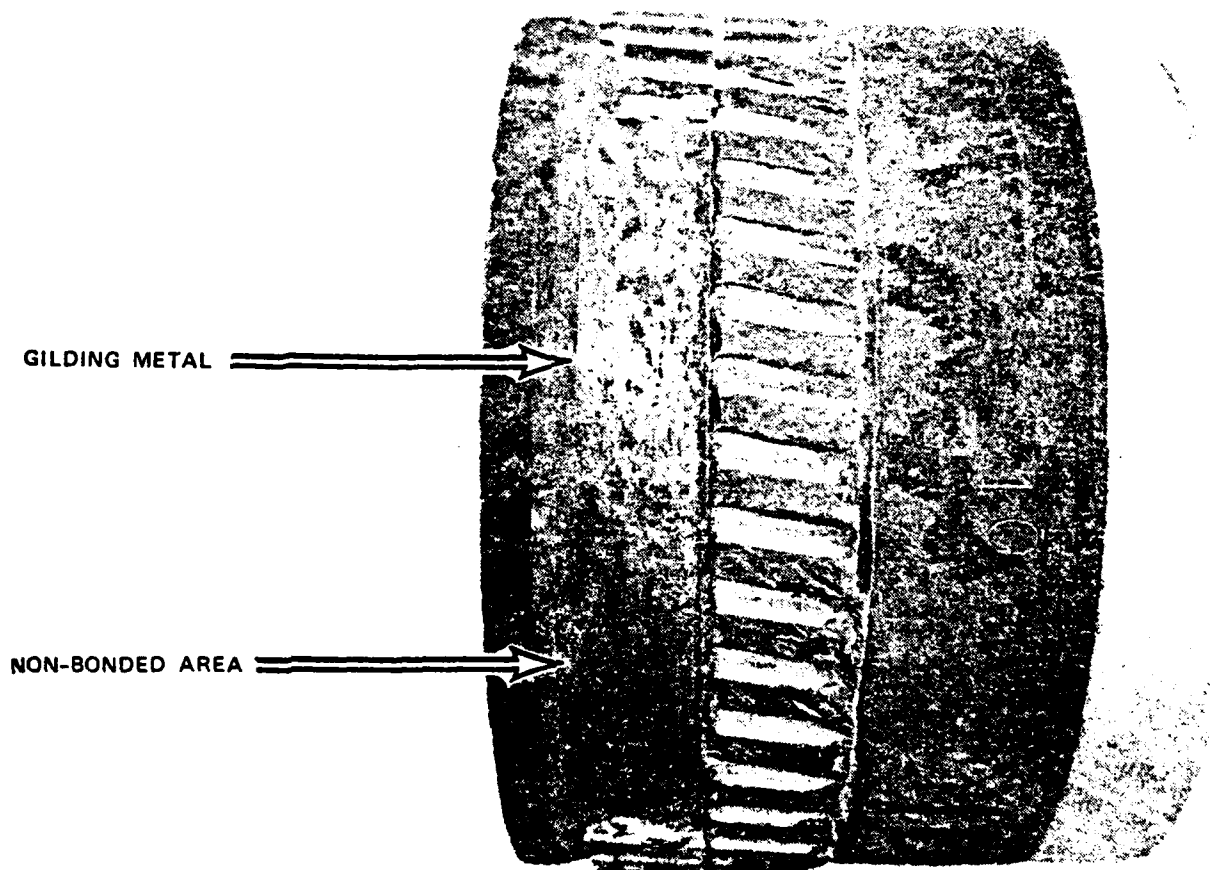
PHOTOGRAPH NO. 10801

RECOVERED M483A1 BAND SHOWING HOW SEPARATION CONTINUES FROM NON-BONDED
AREA INTO BONDED AREA.

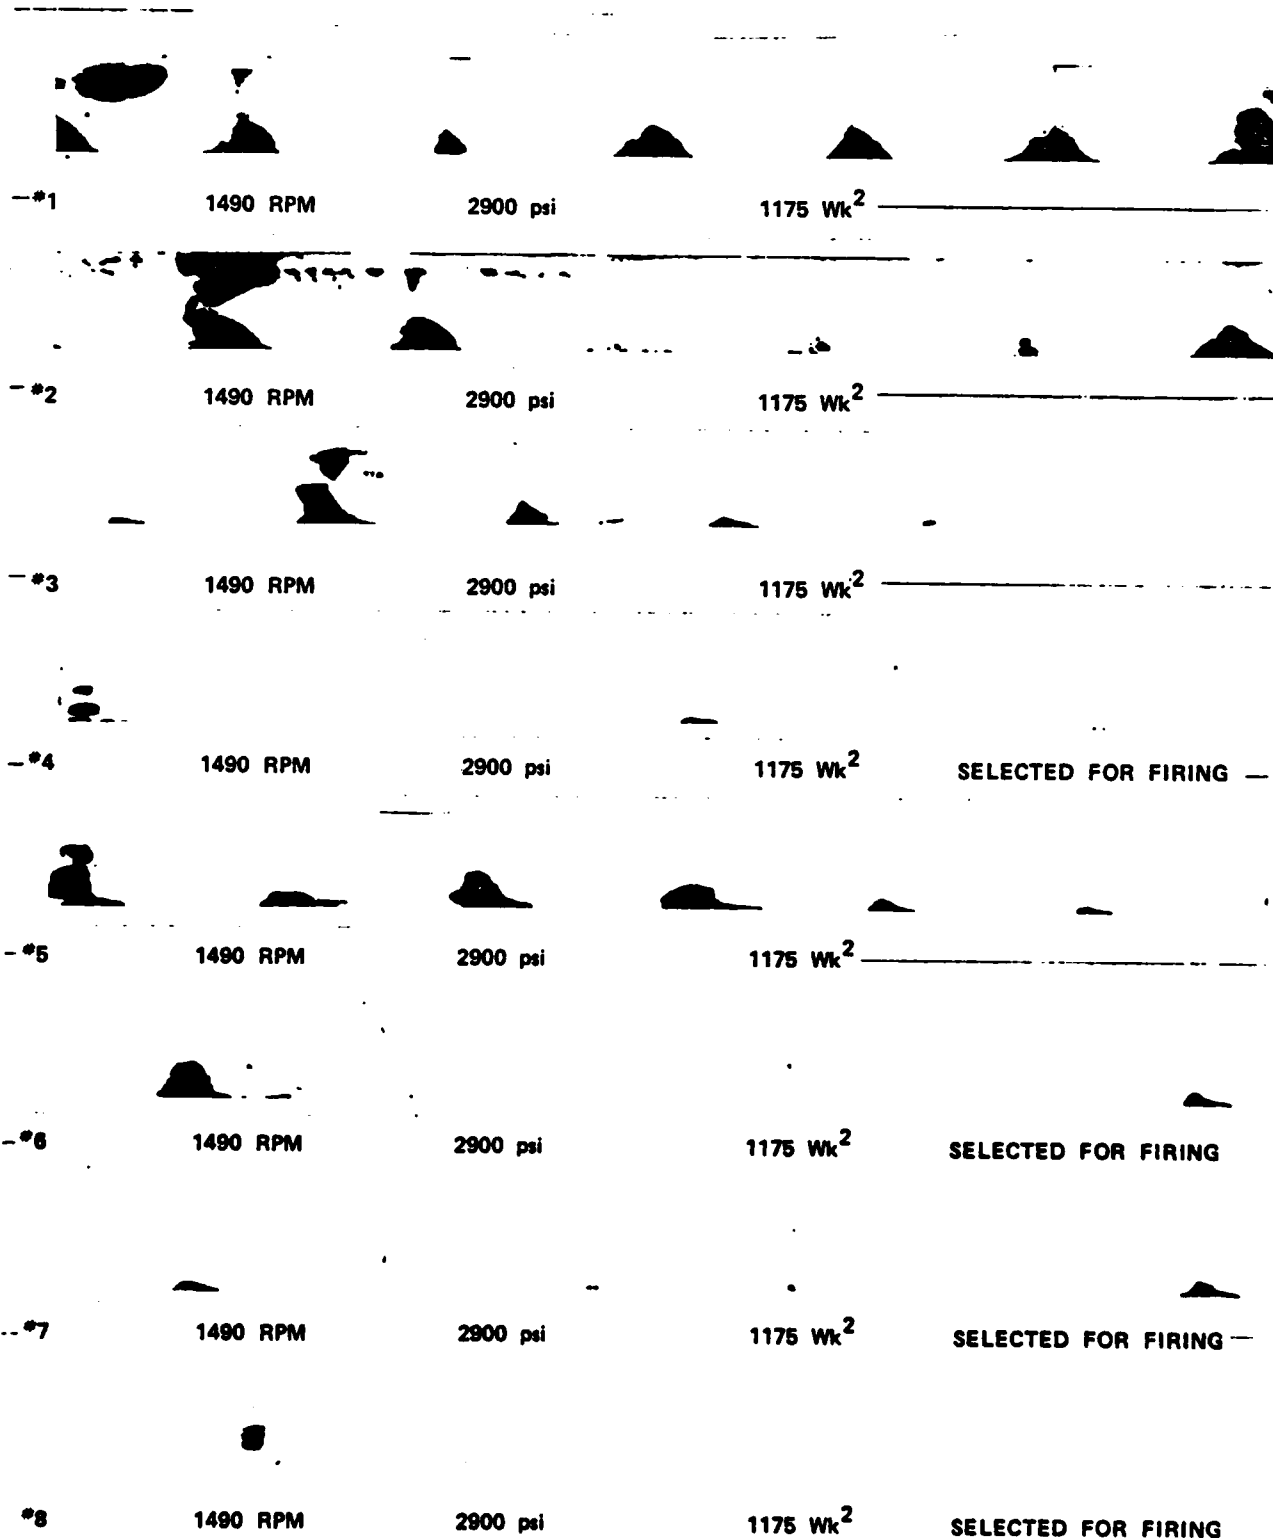
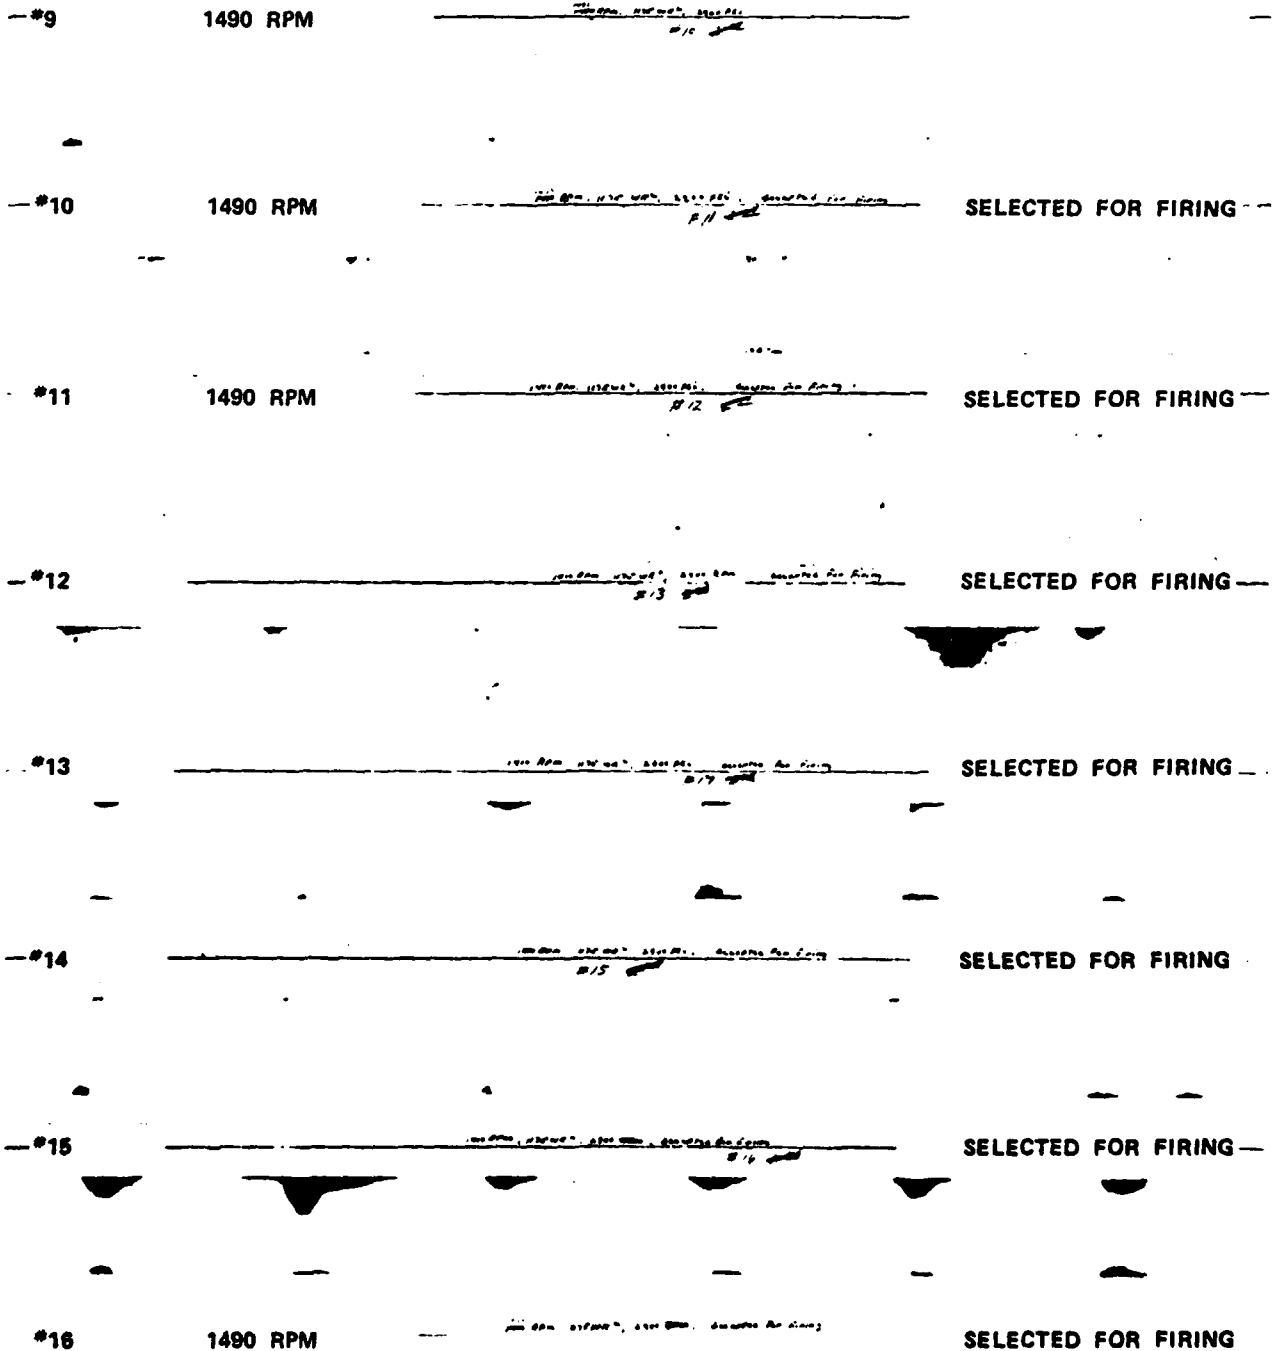
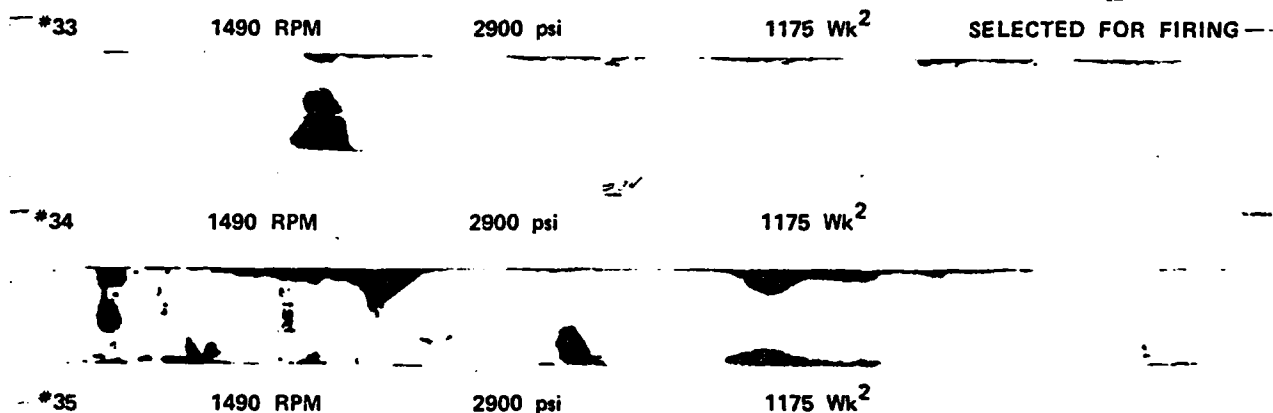
PHOTOGRAPH NO. 10670 Scans #1 through #8 Page 1 of 5

ULTRASONIC SCANNING RESULTS FOR BANDS 1 THROUGH 35 INERTIA WELDED TO M483 PROJECTILE BODIES. DARK AREAS INDICATE NO BONDING.

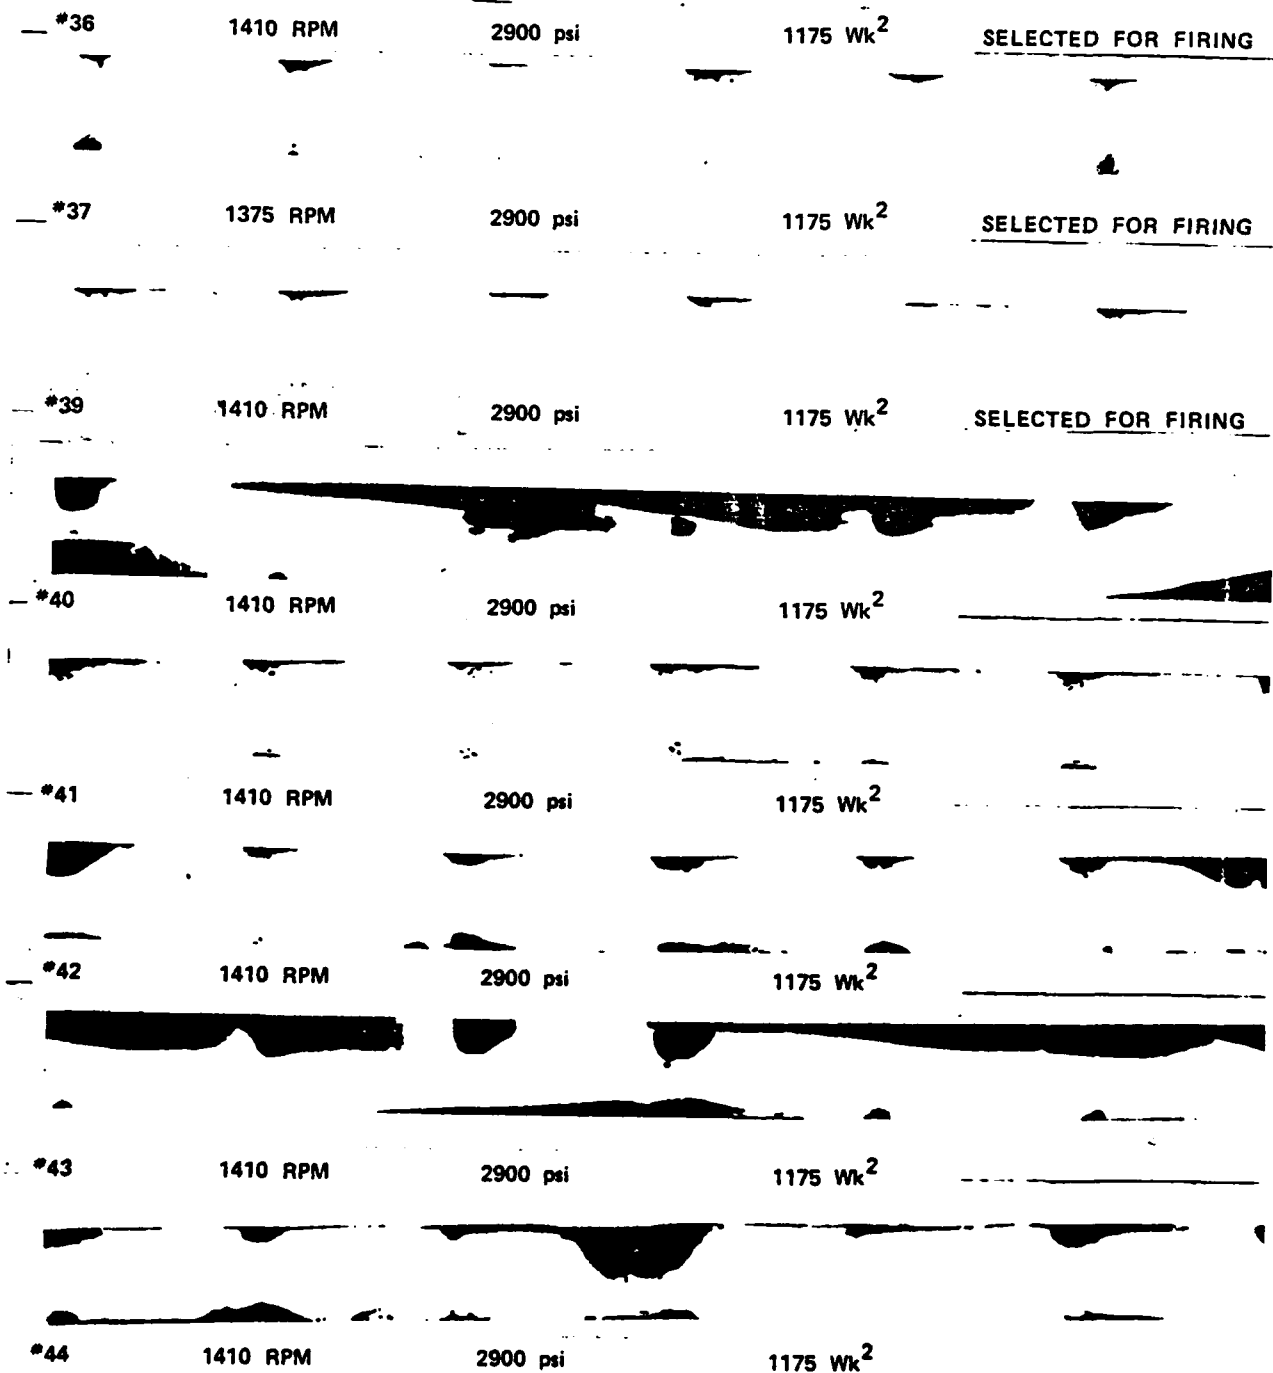
PHOTOGRAPH NO. 10669 Scans #36 through #44

ULTRASONIC SCANNING RESULTS FOR BANDS 36 THROUGH 44 INERTIA
WELDED TO M483 PROJECTILE BODIES. DARK AREAS INDICATE NO
BONDING.

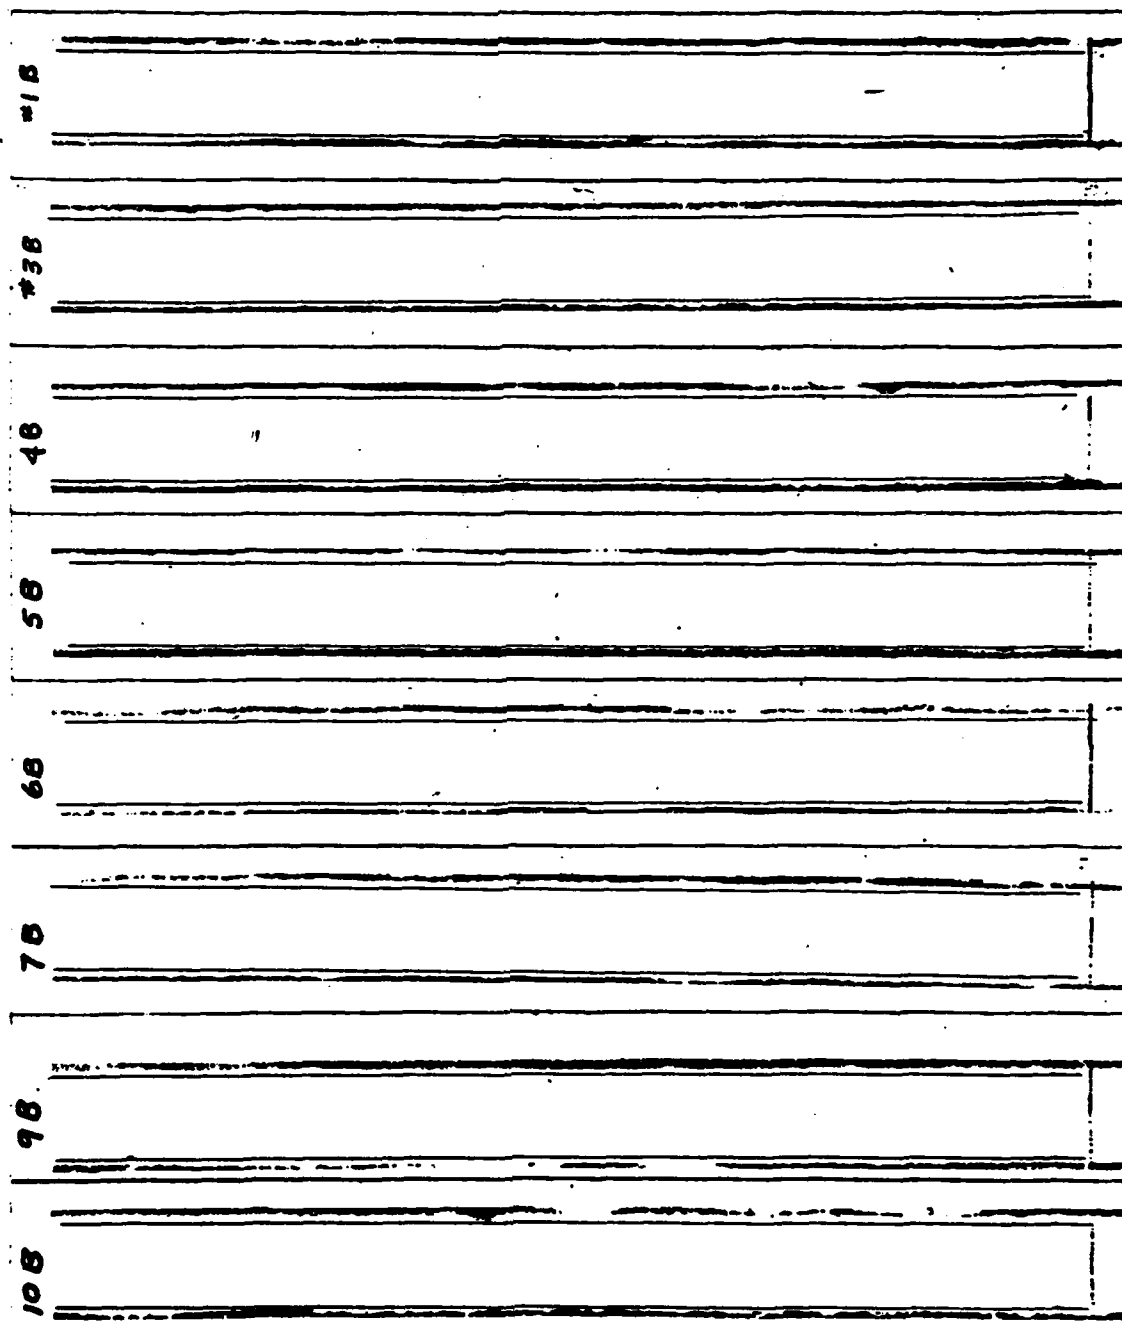
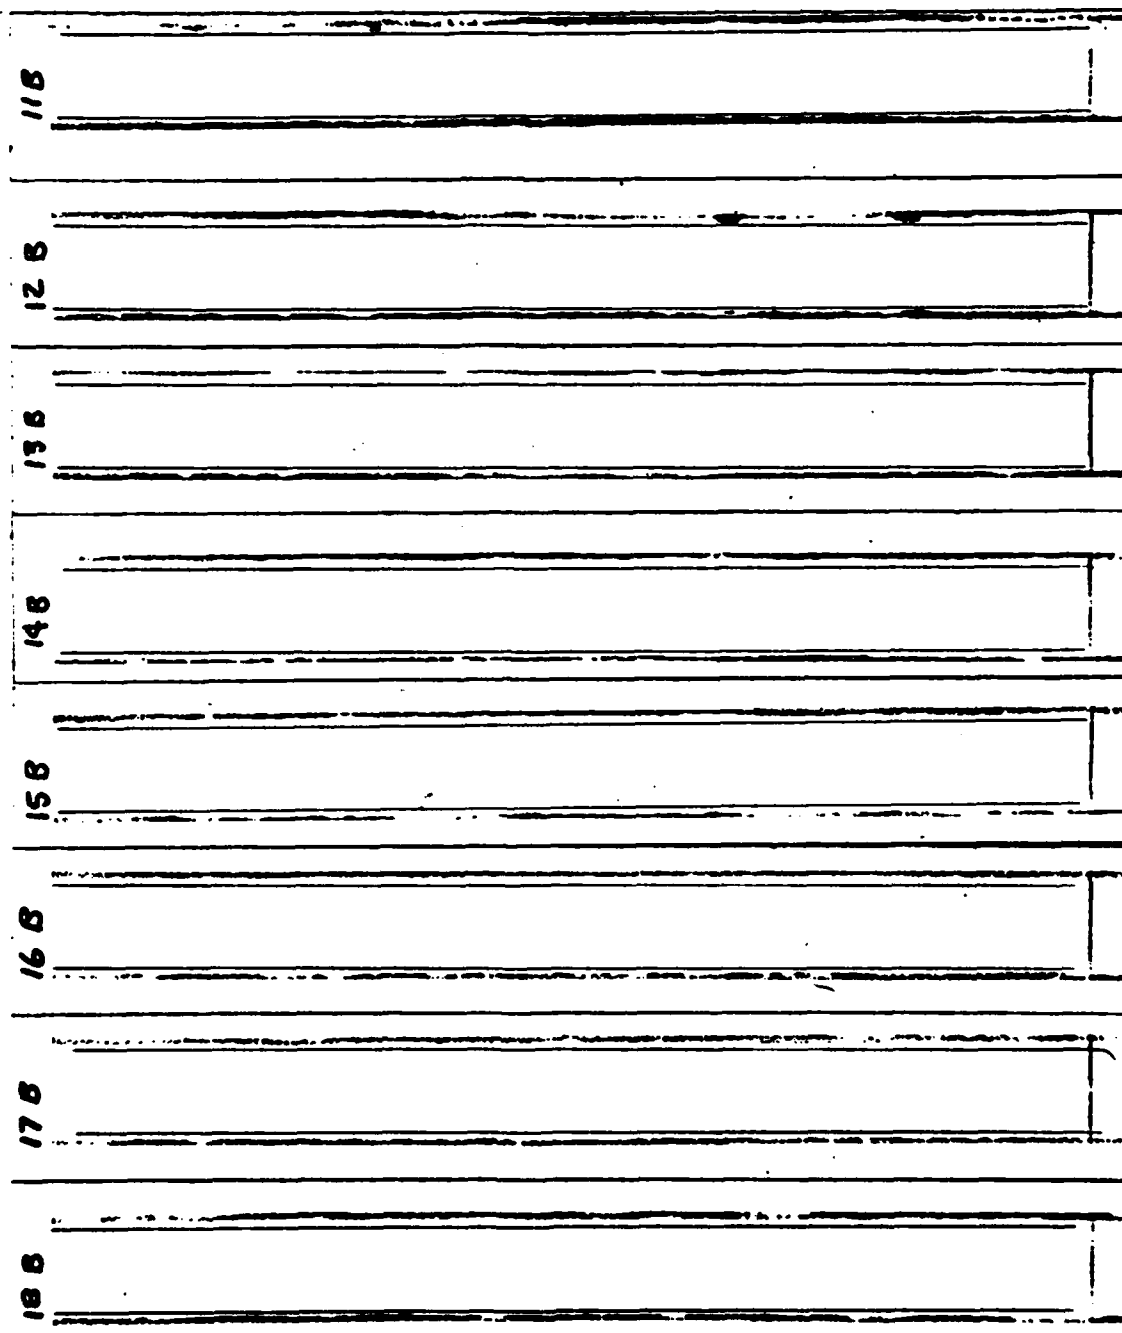
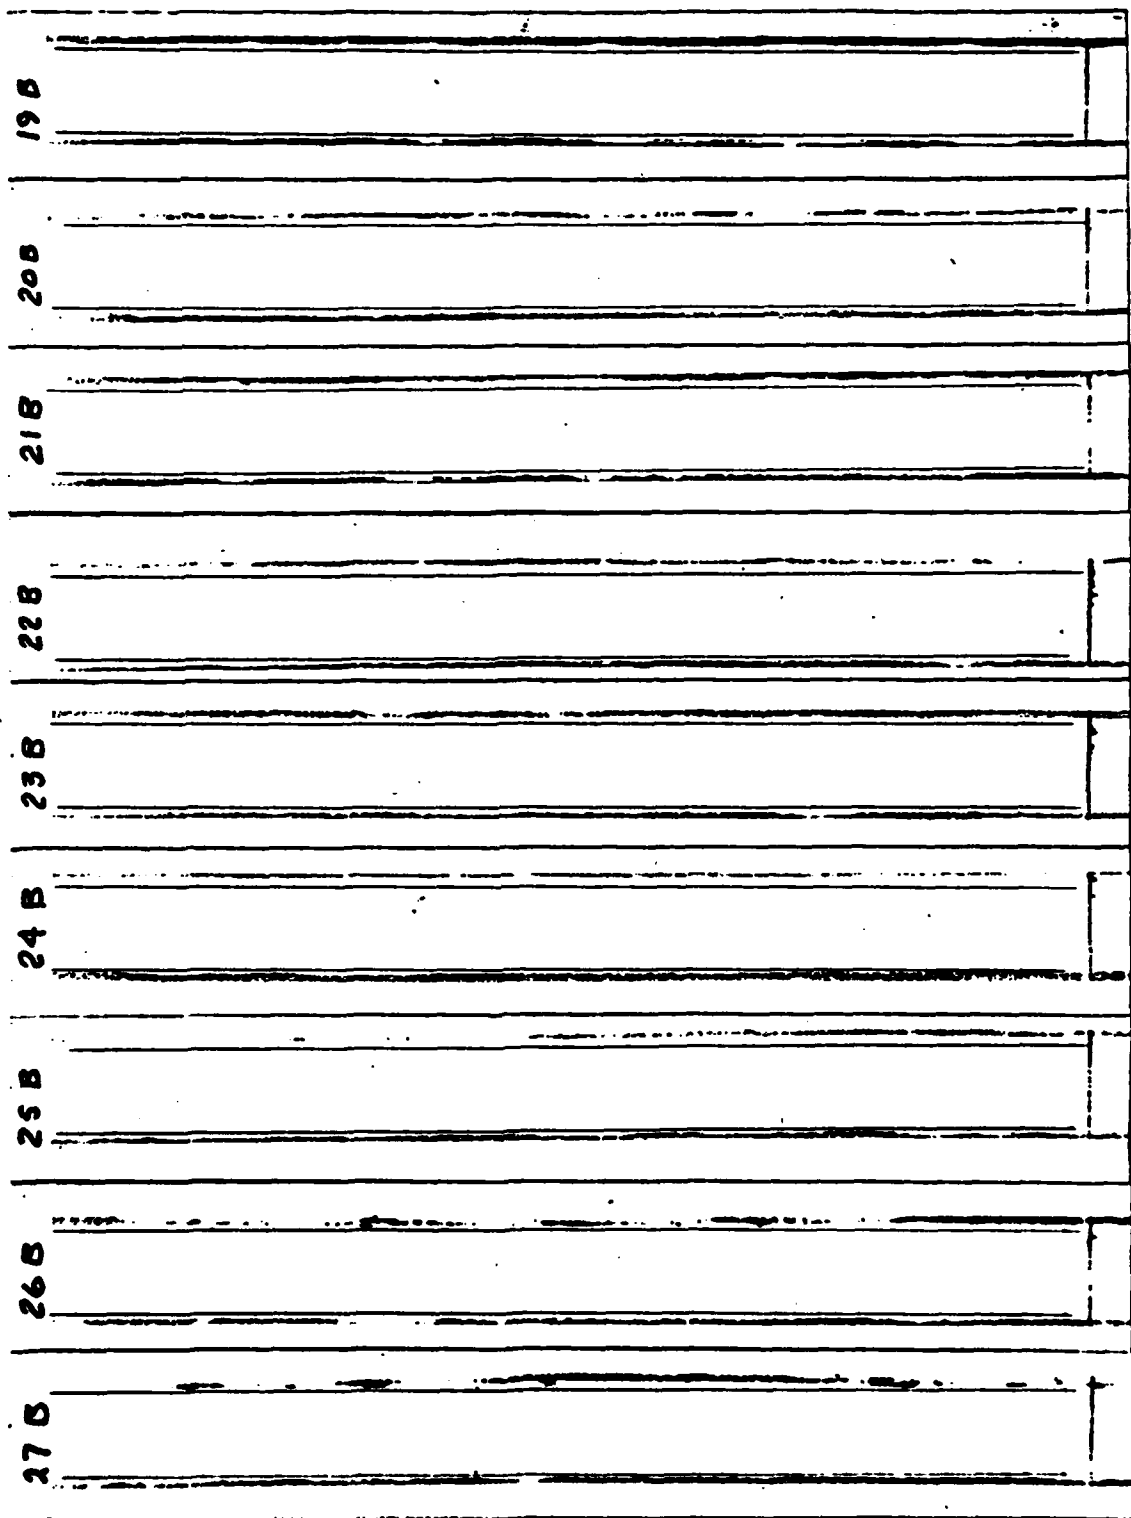
PHOTOGRAPH NO. 10802

Ultrasonic Scans For 25 M483A1 Projectiles Having Rotating Bands Inertia Welded Before Projectile Heat Treatment. Inertia Weld Parameters --- 2,200 rpm Flywheel Rate, 425 wk² Flywheel, 3,800 psi Tailstock Ram Pressure.

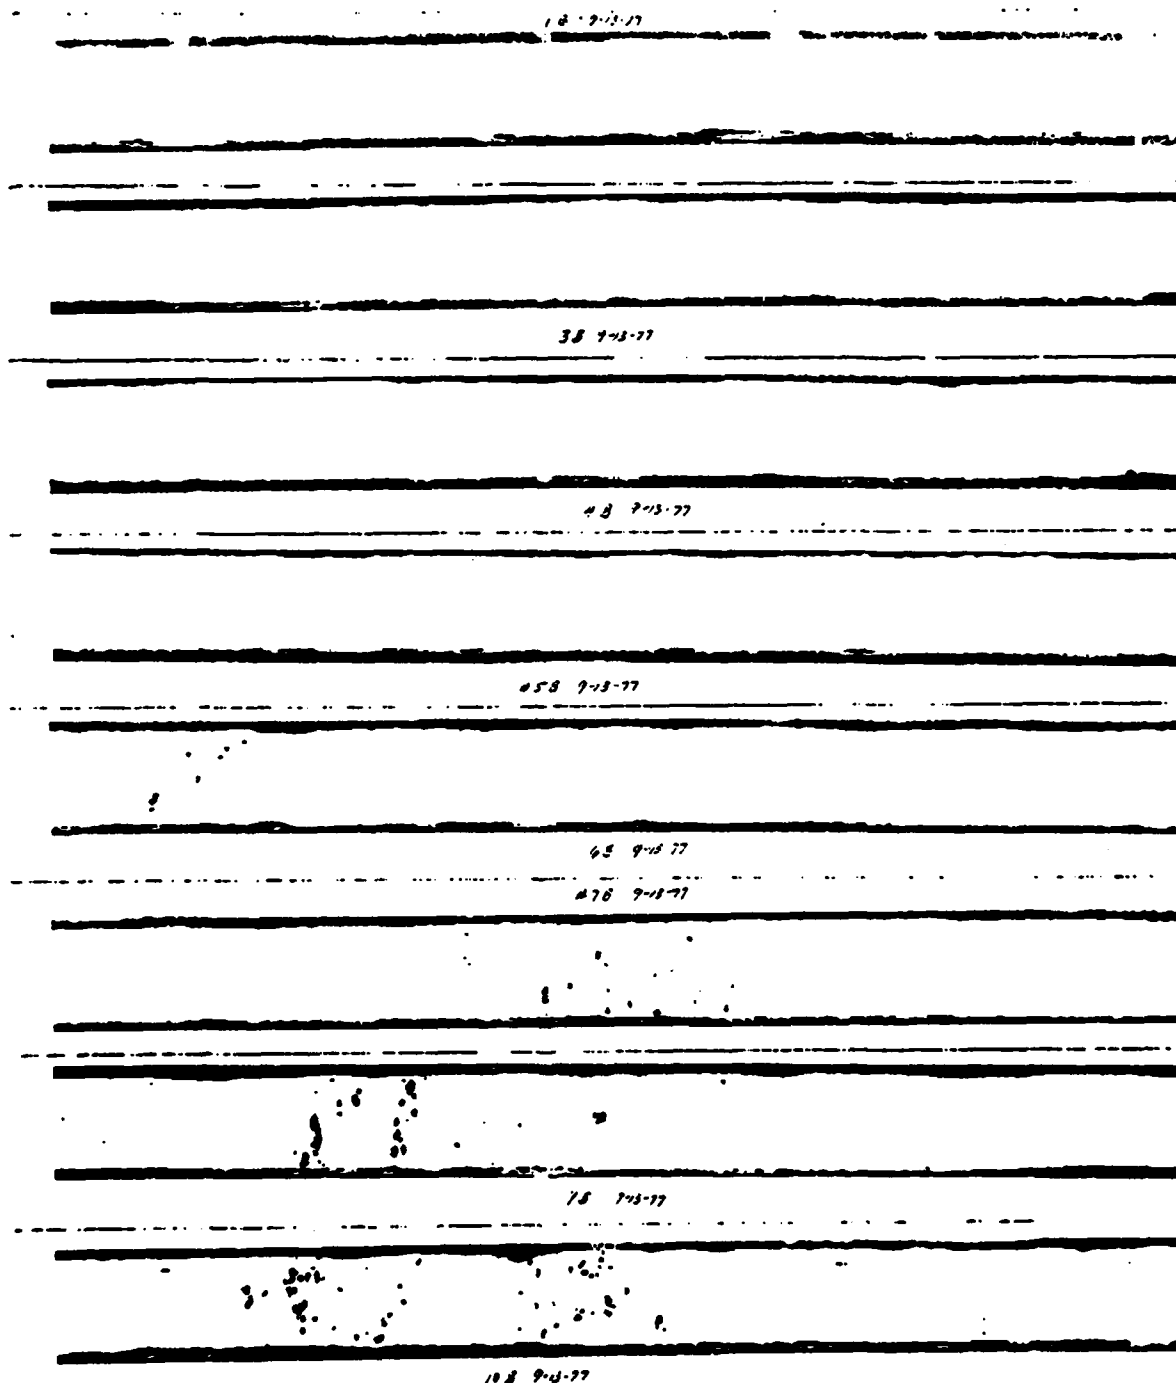
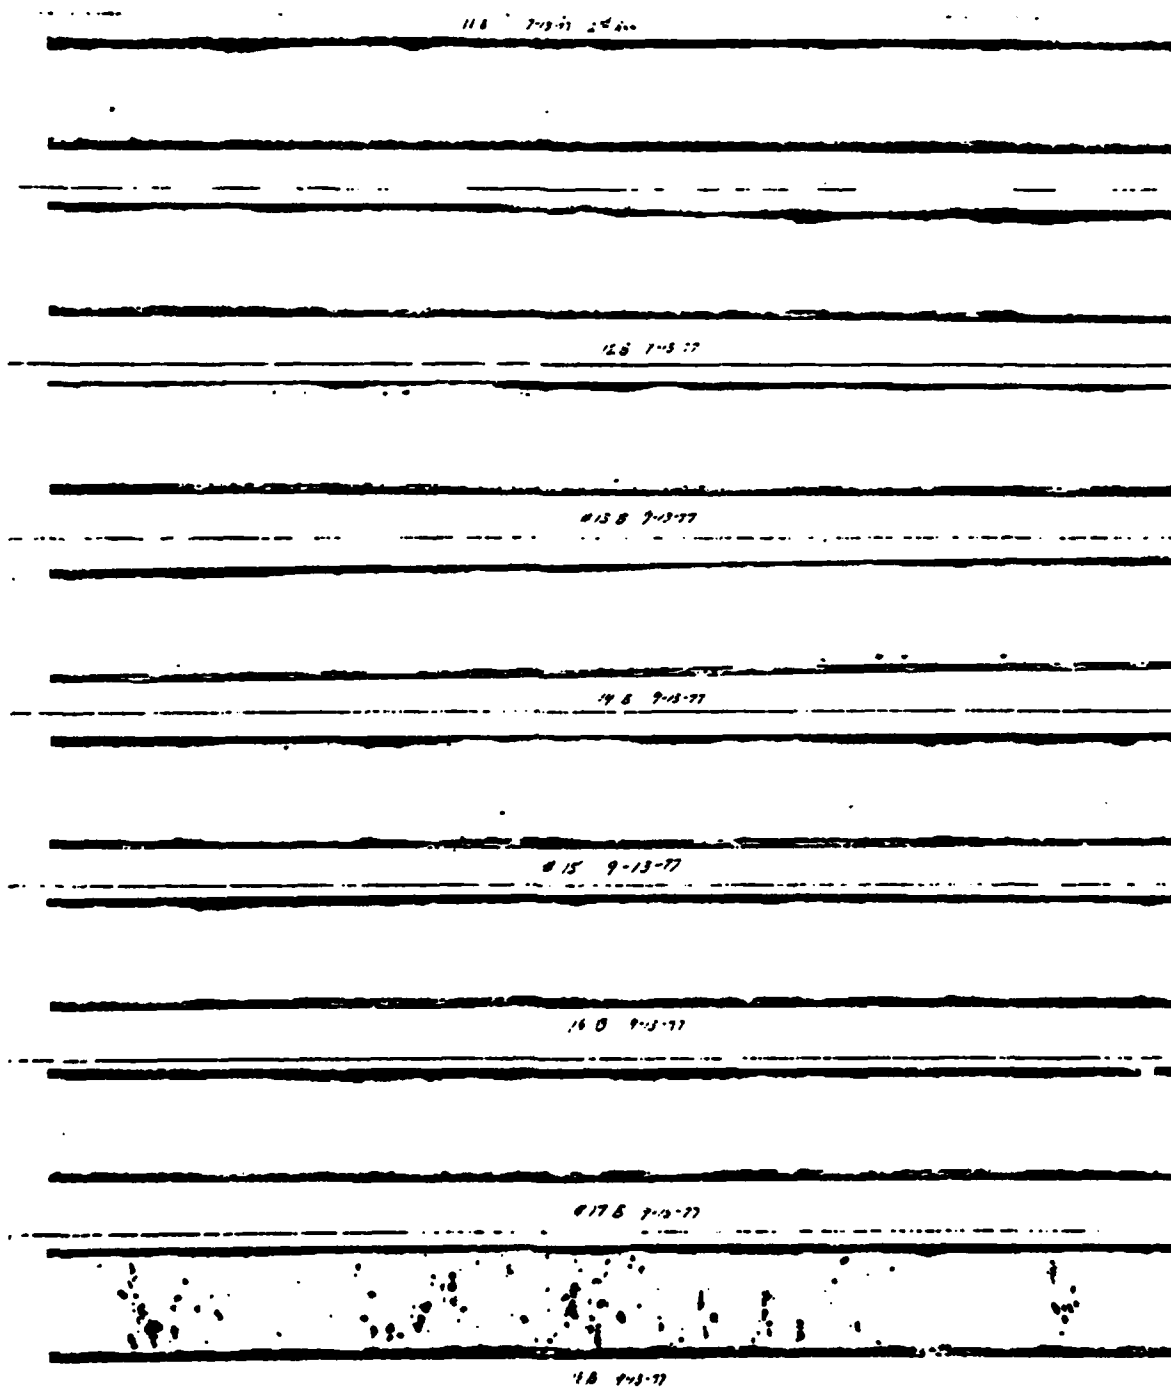
PHOTOGRAPH NO. 10818

AFTER HEAT TREATMENT ULTRASONIC SCANS OF M483A1 PROJECTILES BANDED BEFORE
HEAT TREATMENT. HEAT TREATMENT ACCOMPLISHED DURING SEPTEMBER 1977.

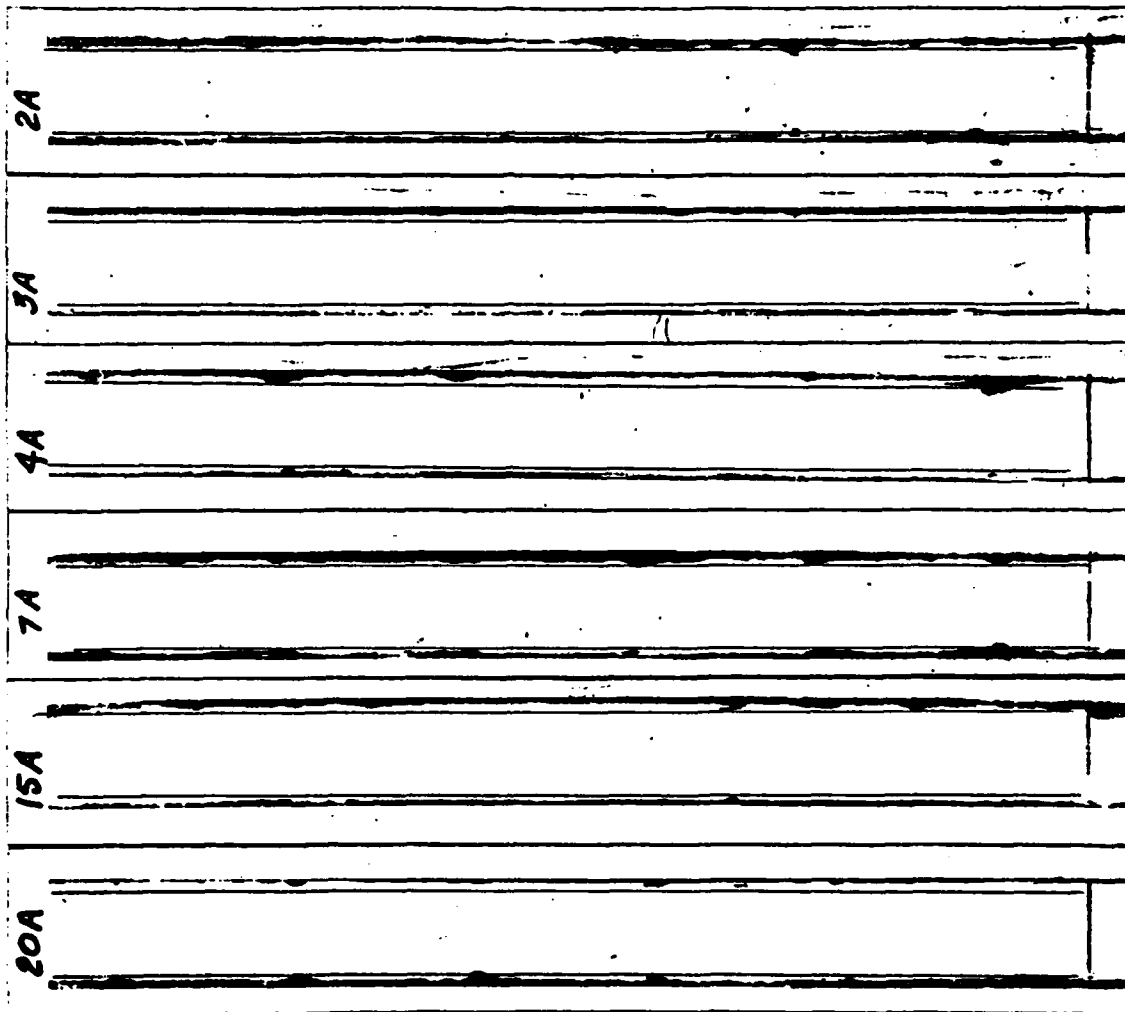
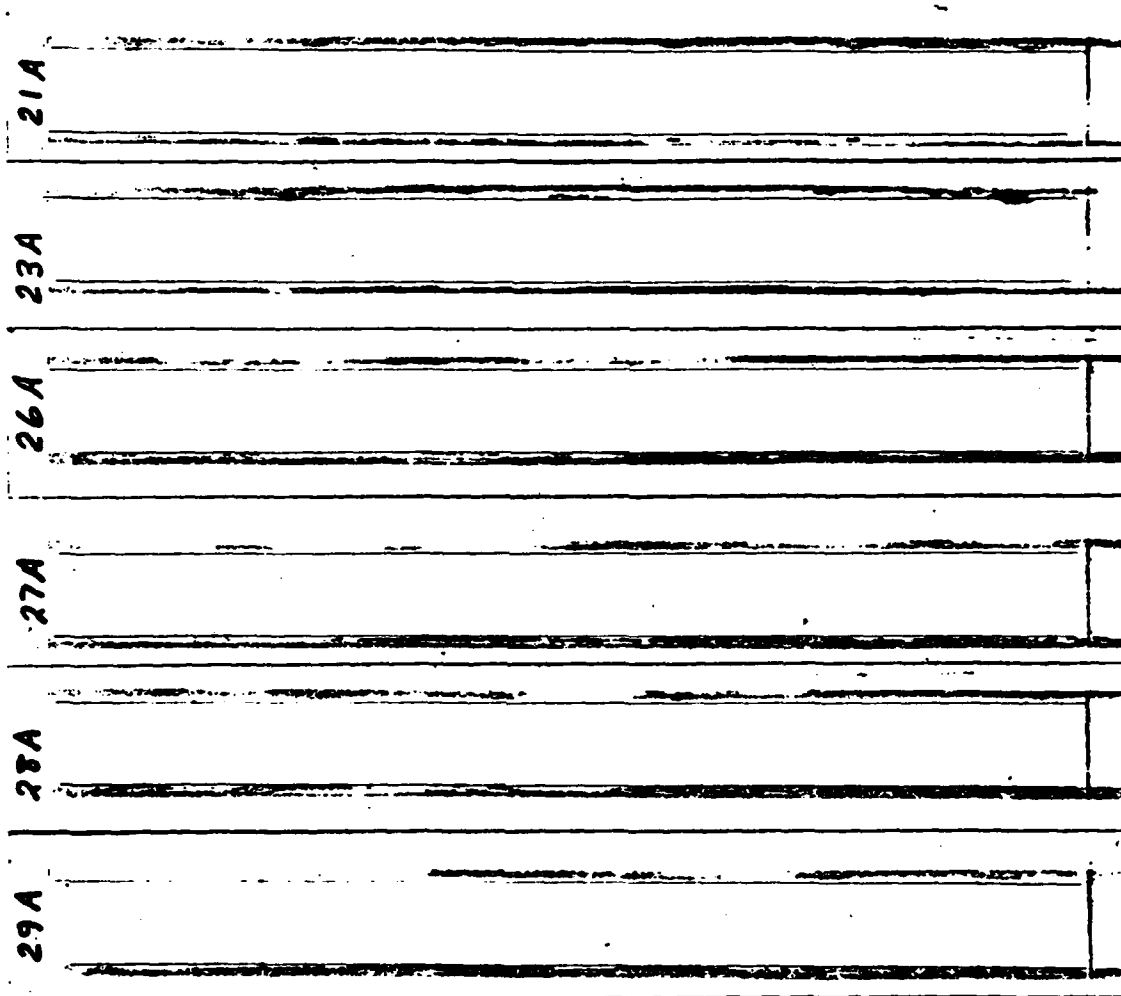
PHOTOGRAPH NO. 10803

Ultrasonic Scans For M483A1 Projectiles Banded By Inertia Welding After Heat Treatment. These Rounds Selected For firing. Weld Parameters --- 2,200 rpm Flywheel Rate, 425 wk² Flywheel, 3,800 psi Tailstock Ram Pressure.
